COMPOSITE OF EXPANDORAM II MODIFICATIONS

TECHNICAL BULLETIN NO. 105

APRIL 1980

EXPANDORAM II

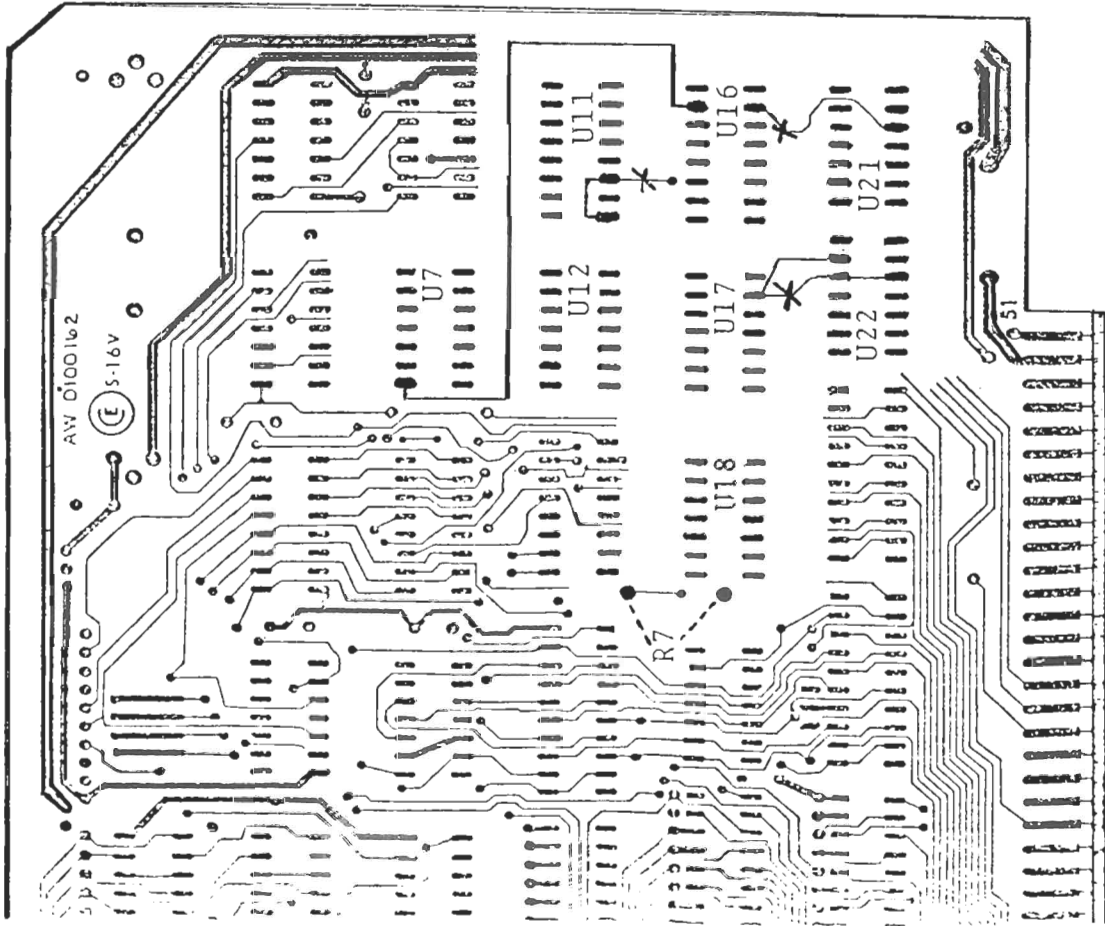
MODS TO BE MADE TO THE EXPANDORAM II

Extensive field usage and further R&D in our engineering department has determined that the ExpandoRAM II could hang up in Wait State Refresh cycles under certain conditions. The modifications delineated below solve this problem:

1. Examine diagram to left and locate the three traces marked with an 'X'. Double check to ensure that you have the correct traces and then cut them with a sharp knife. Make the cut deep and 'v' shaped to make sure that the connection is broken.

1. Change U6 from 74LS74 (Low-Power Schottky) to 74S74 (Schottky).
2. Change R7 from 10K ohms to 20K ohms.
3. Using the diagram on the back of this page, rework boards to change WAIT STATE REFRESH TIME to leading edge of $\phi 1$.
 - a. Cut etch from U11-14 to U16-7
 - b. Cut etch from U16-10 to U21-10
 - c. Cut etch from U17-9 to U22-5
 - d. Connect an insulated jumper wire from U11-14 to U11-16
 - e. Connect an insulated jumper wire from U7-1 to U16-7
 - f. Connect an insulated jumper wire from U17-9 to U22-6

2. Locate U7; note the only connection and follow it to U16. Using an insulated wire, complete the connection as shown.
3. Locate U11; note the only connection is a jumper between two pins on U11. Using an insulated wire, complete the connection as shown.

4. Locate U17; note the new connection and follow it to U22. Using an insulated wire, complete the connection as shown.
5. Locate R7 to the left of U18; its solder points are indicated by dotted lines. Remove R7 and replace it with the 20K Ohm resistor provided.

6. Turn your PC board over and locate U6. With a small flat blade screw driver, gently and slowly pry U6 out of its socket. Note the way it is placed in the socket. Using the replacement IC provided, line up all pins with the socket. Be sure that the replacement IC is in the correct position and then push it into the socket firmly. Examine closely making sure no pins were bent.
